DEPARTMENT OF NATURAL RESOURCES
DIVISION OF OIL, GAS AND MINING

May 8, 2002

RE: Site Inspections: International Uranium; Hecla Shaft, La Sal-Snowball, Pandora, and Redd Block IV Projects; M/037/043, M/037/026, M/037/012, M/037/046; San Juan County, Utah

Date of Inspection: May 1, 2002
Time of Inspection: about 1:00 to 3:00 p.m.
Conditions: Mostly clear, 50's, windy
Participants: Doug Jensen and Paul Baker, DOGM

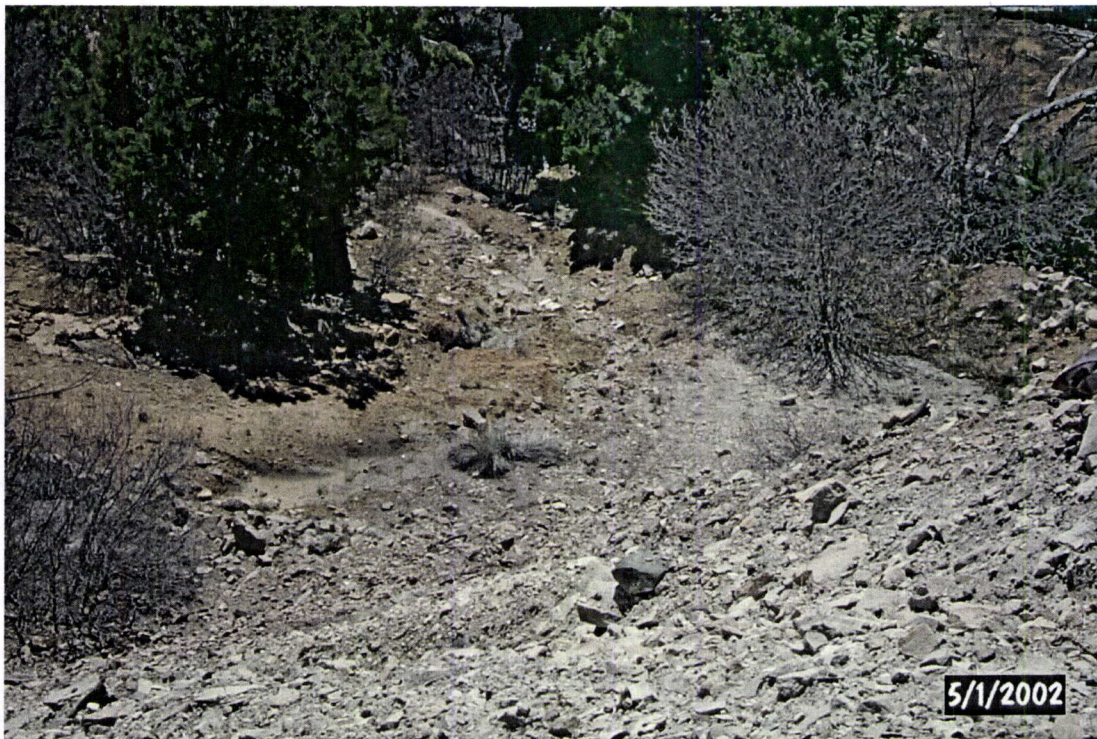
Permit M/037/026 includes both the La Sal and Snowball sites and the Beaver Shaft. At the Snowball site, there has been some erosion from the waste piles (Photo 1), and it appears some of this material has gotten into the drainage (Photo 2). Photo 3 shows some buildings at the Snowball Mine.

Photo 1. Waste pile at the Snowball Mine. Note the erosion.

The operator should install a silt fence or straw bales in the drainage below the Snowball waste pile to reduce the amount of material getting into the drainage. Otherwise, we have no other long-term maintenance suggestions.

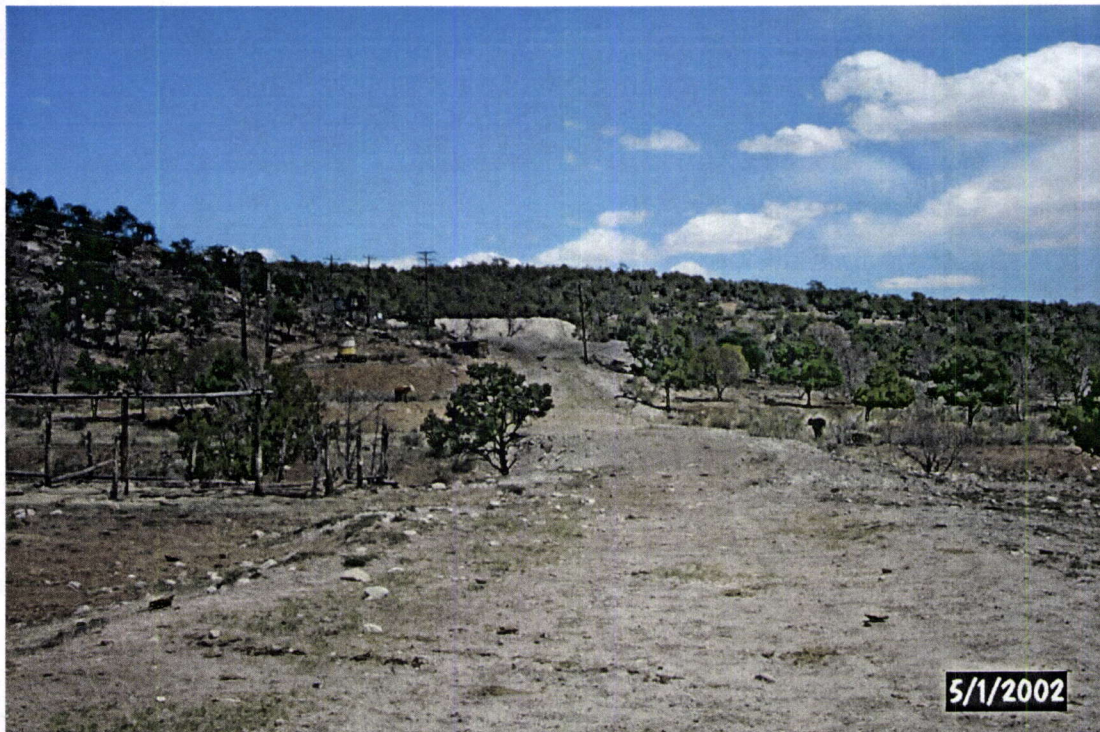
The Snowball and Pandora Mines are both in a canyon, and there would be limited space available to regrade the waste piles although there is some (Photo 4). In places where the waste was stable, there were perennial grasses, sweet clover, small burnett, and other forbs. This indicates the material has some capability of supporting vegetation if it is stable enough for the vegetation to become established. At the site east of the Beaver Shaft (Photo 5), there had been some cattle, and there was also quite a bit of vegetation establishment. It appeared from this that manure would help vegetation establishment on the waste if the waste is used as a growth medium.

Photo 4. Pandora Mine viewed from the Snowball Mine.
